Annual Bridge Report

King County

Department of Local Services
Road Services Division

August 2019

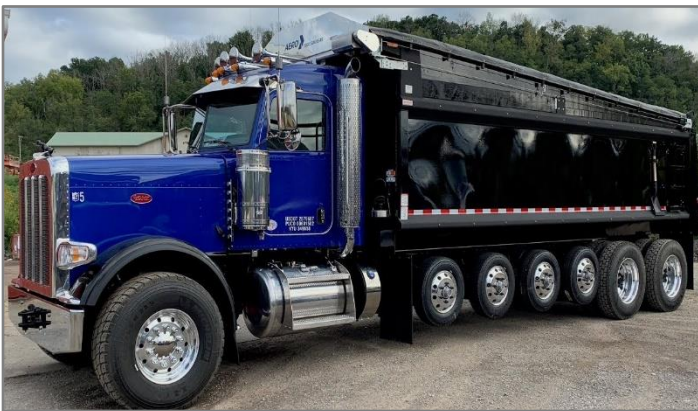
This truck is an example of Single Unit Vehicle classified of a SU7 as it has a total of 7 axles

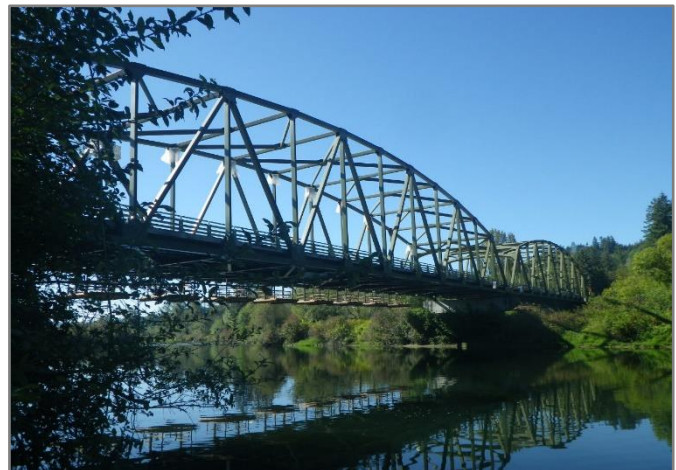
Tolt Bridge No. 1834A elevation view from the west bank of the Snoqualmie River

During load rating analysis for this bridge in early 2017, engineers discovered deficiencies in the connection details and the bridge was posted for a 6-ton gross vehicle load limit.

The County Executive declared an emergency in June 2017 allowing Roads to perform bridge repairs immediately. The bridge was temporarily posted and lane restricted during the repair construction. Repairs included adding or replacing close to 7,000 higher-strength bolts and adding about 28,000 pounds of new splice and gusset plates at 80 truss joints. In November 2018, construction was completed and the bridge was re-opened without lane or load restrictions.

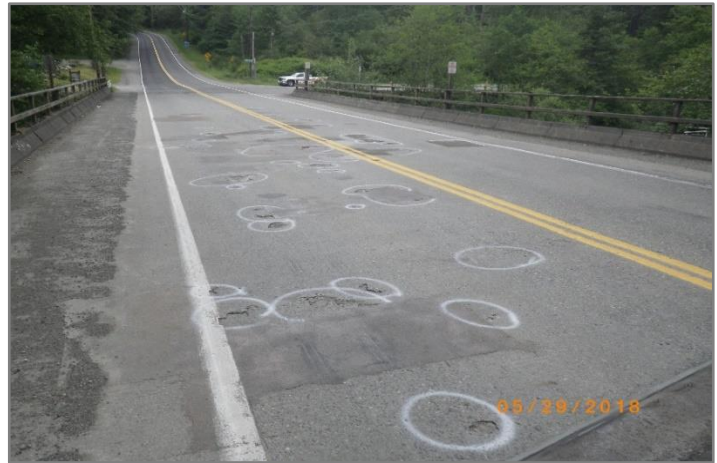
Landsburg Bridge No. 3075 deck surface with patched areas and spalls

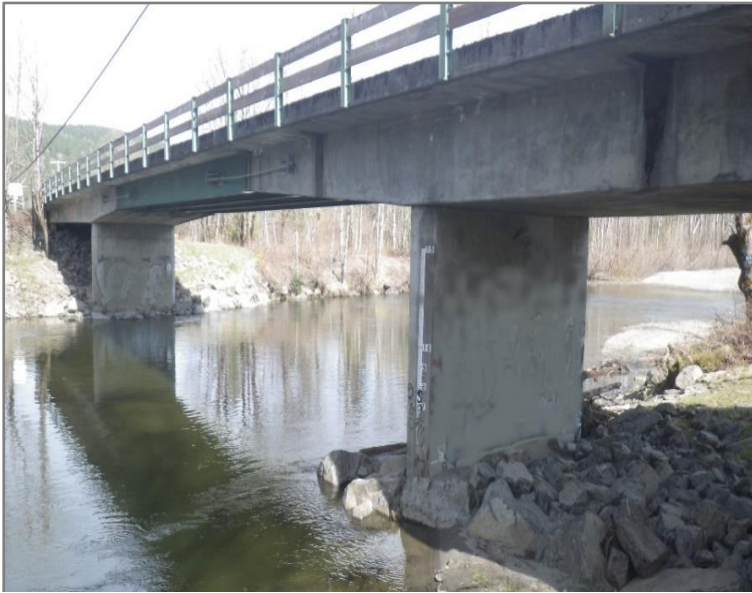
This bridge has been experiencing flooding related damage over the years due to the flooding in the Snoqualmie River and the beaver dams in the upstream wetland area. A flood event in November 2018 caused additional scour damage and subsequently the bridge had to be closed to all vehicles since the south approach was undermined and the creek had undercut and jeopardized the previous scour repair. Repairs will include abutment protection, creek stabilization and installation of riprap. If Flood Control District funding is secured in 2019, construction is proposed for 2021.

North Fork Bridge No. 122i Looking south to the bridge and left bank of the North Fork Snoqualmie River

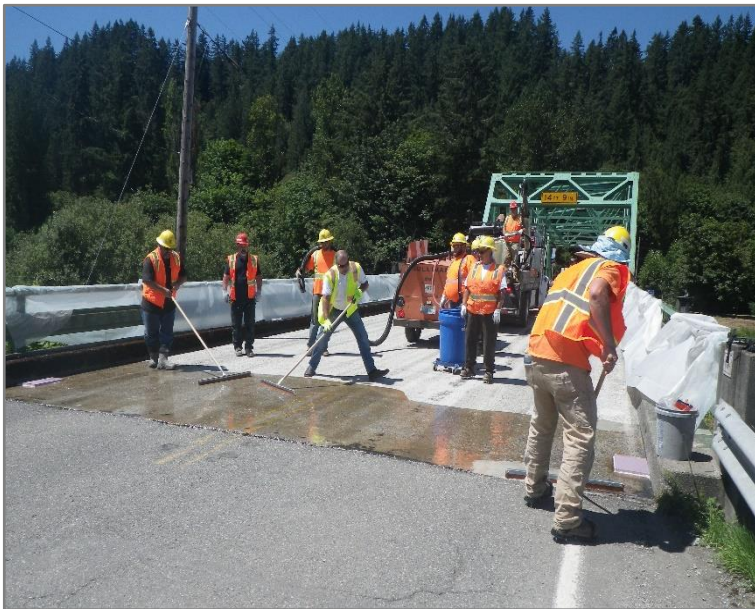
Stossel Bridge No. 1023A, bridge maintenance crew is applying an epoxy overlay to the original concrete deck

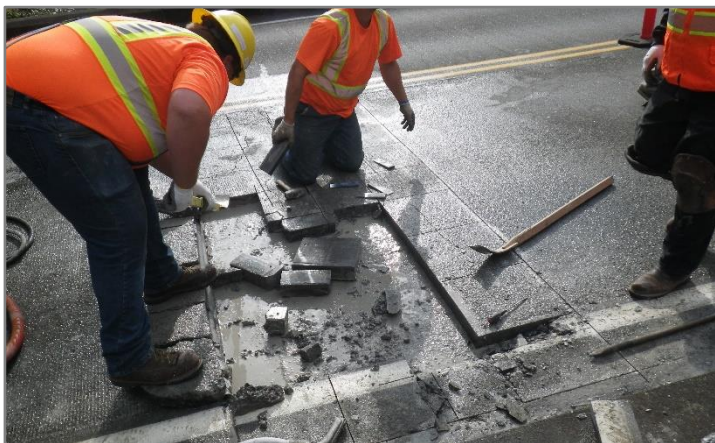
The bridge maintenance crew is removing cracked deck concrete on Brissack Bridge No. 1116A

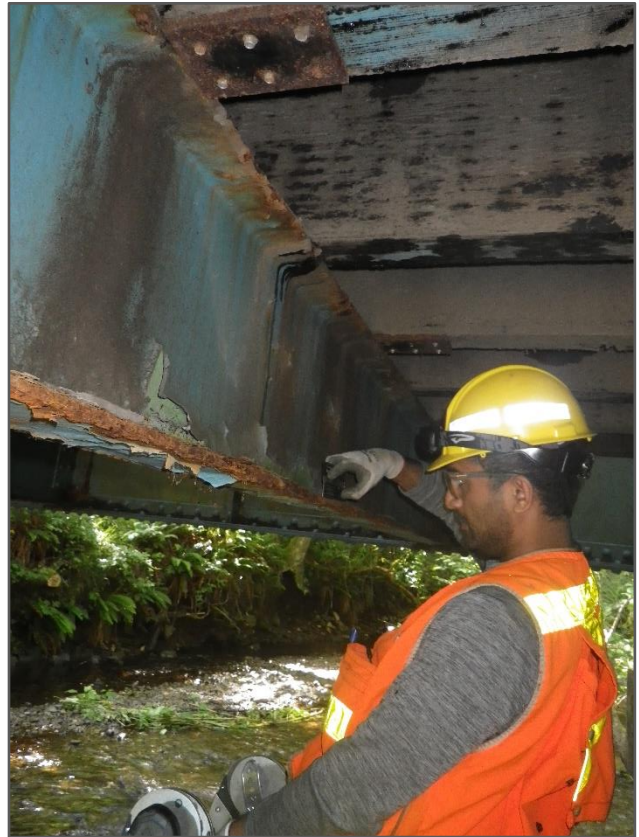
The bridge is 41 feet long and 18 feet wide. The steel girders and floor beams of this bridge are over 100 years old; they were originally in place at another bridge location in 1912 and moved to this site in 1958. The bridge is fracture-critical and the floor beams have extensive corrosion and section loss. Due to the condition of the floor beams, the bridge is being inspected every six months. The bridge is load restricted with a reduced advisory speed limit of 15 miles per hour. In addition to the severely corroded steel and limited load capacity, other deficiencies include deteriorating creosote timber piles, rotten timber backwall planks, substandard rails, and downstream bank erosion.

Inspector measuring steel loss on the floor beams of Coal Creek Bridge No. 3035A

Roads was awarded federal funding in November 2017 and funding was obligated and authorized in May 2018 to proceed with design for the project. A consultant contract for design was executed in 2018 and a kickoff and chartering meeting was held in December 2018.

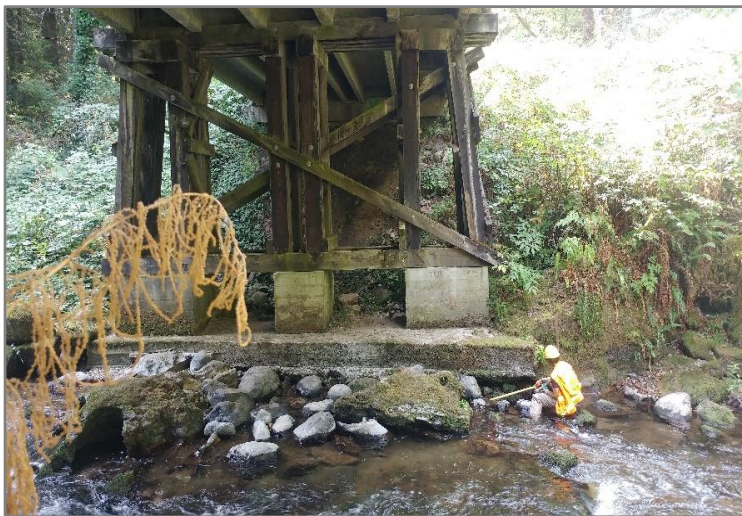
The 68 year old structure is approaching the end of its useful life, the narrow hydraulic opening is constricting the water flow, and the bridge abutments are constructed of creosote timber, which can leach into the water and impact water quality, fish and wildlife. It is not feasible to repair or rehabilitate the bridge to meet current standards for structural, geotechnical, hydraulic and environmental requirements. Procurement of a design consultant will occur in 2019.

Inspector measuring the scoured exposed footing at Upper Tokul Creek Bridge No. 271B

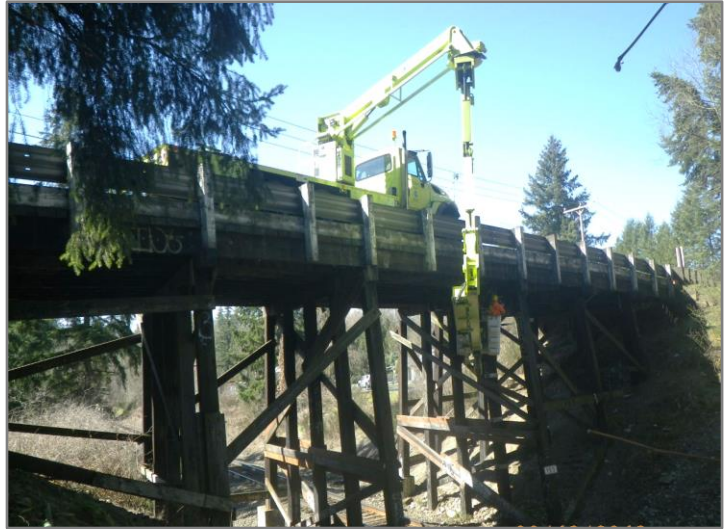
Berrydale Overcrossing No. 3086OX

This trestle was constructed in 1931 of creosote-treated timber. It carries Kent-Black Diamond Road, which is a high-volume arterial, over the BNSF Railroad corridor. It has a posted speed limit of 40 miles per hour and a high daily traffic count of 7,293 vehicles per day. The bridge deck is very narrow (24 feet from curb to curb), with no shoulders or sidewalk. It also has substandard rails and substandard sight distances due to the vertical curve of the roadway. The bridge is structurally deficient with a sufficiency rating of 21.84 out of a possible score of 100 based on the National Bridge Inspection Standards. The bridge is past its useful service life, and requires frequent, major and costly repairs.

UBIT Inspection on Berrydale Overcrossing Bridge No. 3086OX

Although full funding for replacement of the bridge and its approach roadway is uncertain, because of the criticality of this corridor, initial preliminary design work was funded in the 2017-2018 Roads Operating Budget. The project is complex as it involves coordination with BNSF Railway, a difficult vertical curve sight distance issue, and construction impact to the traveling public. Coordination began in 2017-2018 with BNSF Railway and the completion of the TS&L report for a replacement structure is planned for 2019-2020.

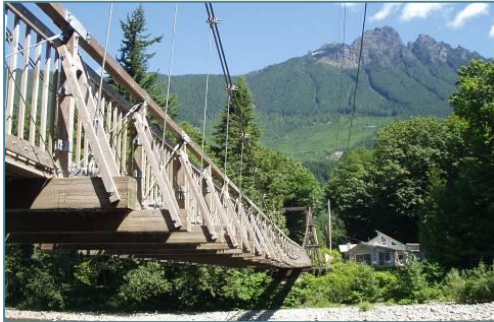
Baring Bridge No. 509A

Built in 1930, this timber suspension bridge spans the South Fork Skykomish River at Northeast Index Creek Road, near the community of Baring.

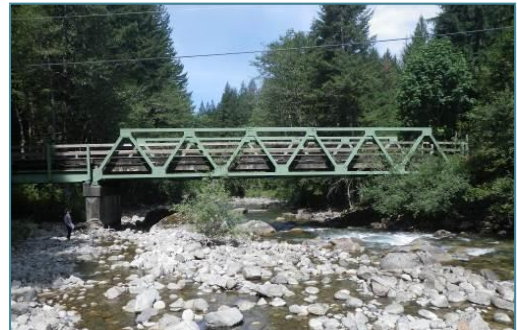
Built in 1951, spanning a tributary to the Skykomish River in northeast King County. This warren pony truss was added to the National Historic Registry in 2002.

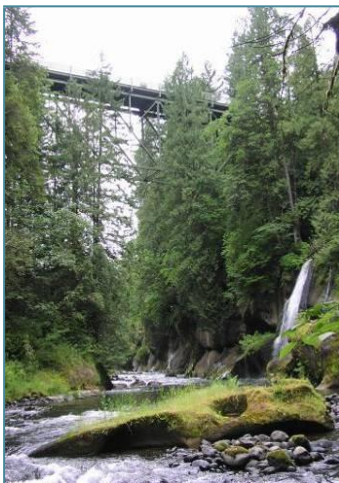
Green River Gorge Bridge No. 3032

Built in 1914, spanning the Green River Gorge in southeast King County. This is a rare and intact example of the Baltimore Petit deck truss structural design. The Green River Gorge Bridge is the only Baltimore Petit deck truss bridge owned and maintained by King County. Designated in 2004.

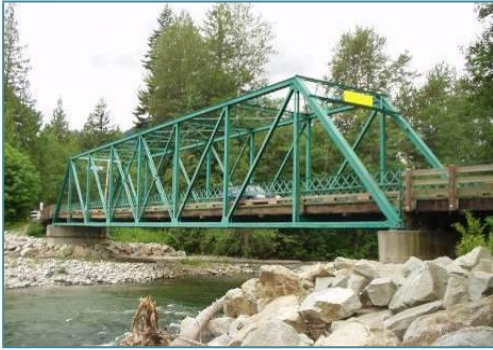
Miller River Bridge No. 999W

Built in 1922, it carries the Old Cascade Scenic Highway over Miller River. This riveted Pratt truss is located near the community of Skykomish. Designated in 1999.

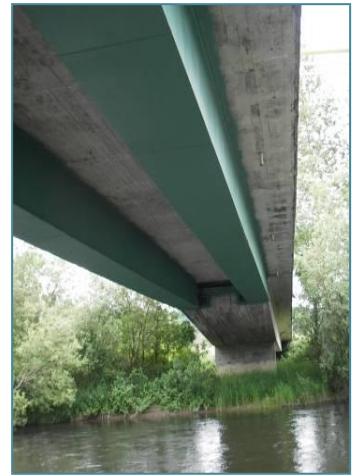
Patton Bridge No. 3015

Built in 1950, spanning the Green River in the vicinity of Auburn. A rare and early example of innovative structural design associated with Homer M. Hadley. In 1995, the Patton Bridge was listed in the National Register of Historic Places and the Washington Heritage Registry. Designated in 2004.

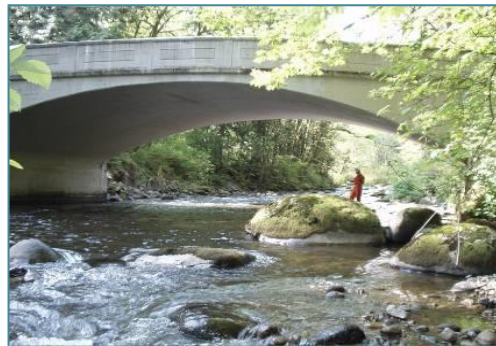
Raging River Bridge No. 1008E

Built in 1915, this bridge spans the Raging River between the communities of Fall City and Preston. It is a concrete earthen-filled arch structure, originally built to carry the Sunset Highway across the Raging River. Designated in 1997.

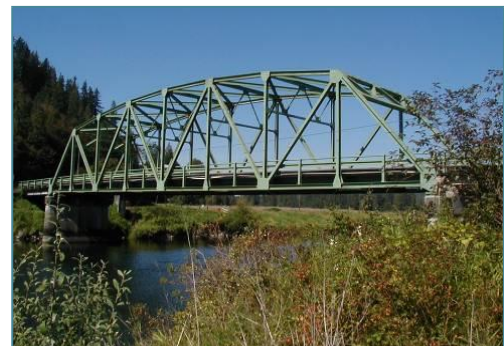
Stossel Bridge No. 1023A

Built in 1951, spanning the Snoqualmie River, this riveted Warren truss is located north of the community of Carnation. Listed on the Washington Historic Registry in 2002. Designated in 1997.
